# **Preliminary report**

## Crash involving Malaysia Airlines Boeing 777-200 flight MH17

Hrabove, Ukraine - 17 July 2014

*The Hague, September 2014*

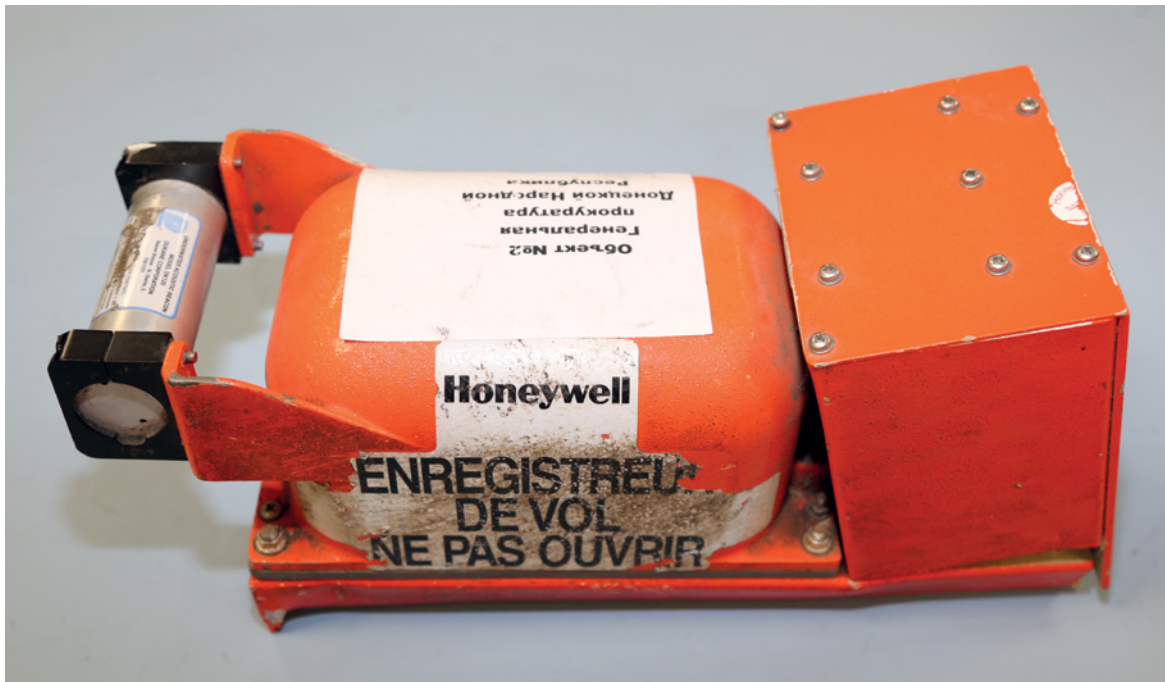
The housing of the CVR (figure 4) had been damaged and, although the model and serial numbers were unreadable on the data plate, the serial number 1366 - matching the one provided by Malaysia Airlines - was found stamped on the underside of the chassis. The external damage found on the CVR is consistent with impact damage, the internal memory module was intact. The recording capacity of this recorder is 30 minutes.

Figure 4: Cockpit voice recorder. (Source: AAI/B)

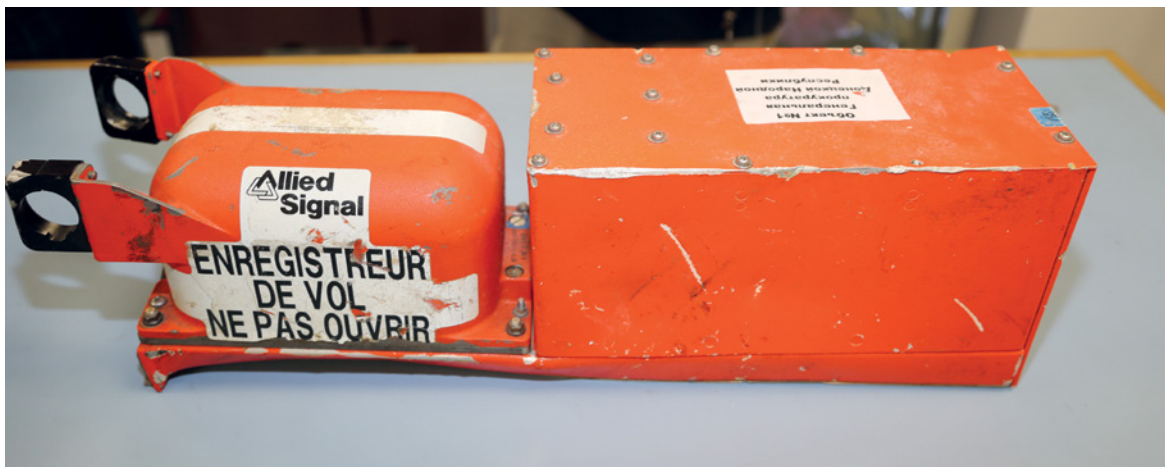
The label on the housing of the FDR (figure 5) showed that it was Allied Signal Model Number 980-4700-003 with Serial Number 2196. These details matched the details provided by Malaysia Airlines. The recorder was found damaged but the internal memory module was intact. The external damage found on the FDR was consistent with impact damage. The FDR, which can record 25 hours of operational data, was successfully downloaded and contained valid data from the occurrence flight.

Figure 5: Flight data recorder. (Source: AAIB)

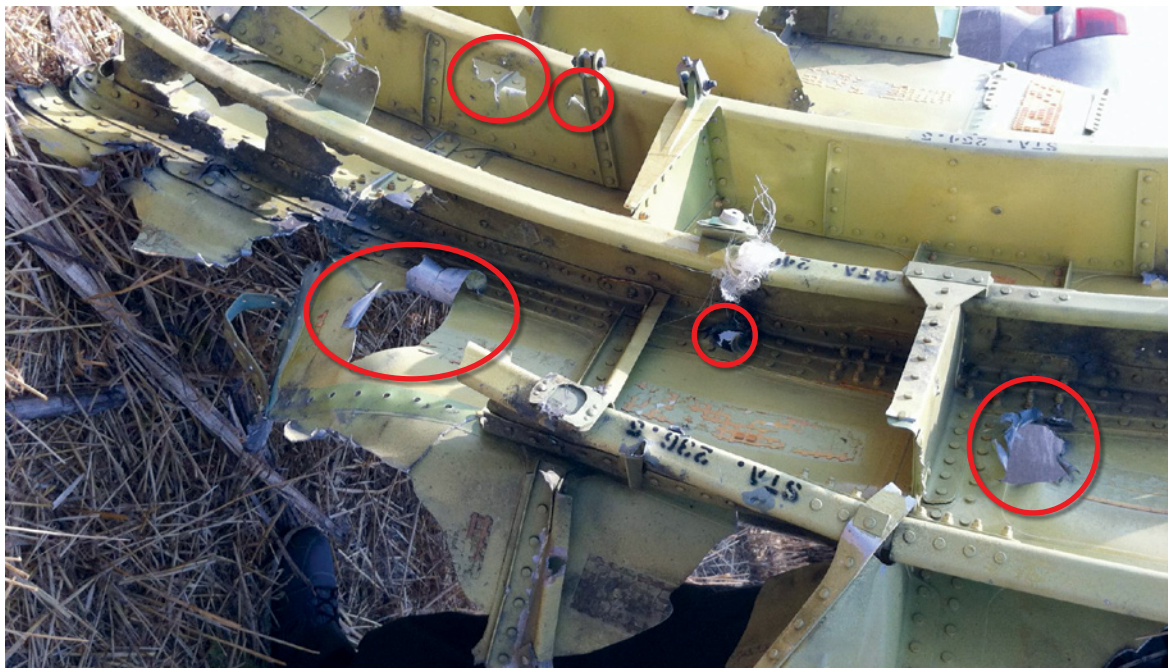
Around 1.7 km north of the position where the cockpit window structure was found, was a section of the cockpit roof also showing holes indicating penetration from outside (figure 9).

Figure 9: Part of the inside cockpit roof, indicating penetration with objects from outside. (Source: DCA)

Noting that the investigation team has not yet had the opportunity to recover these components for forensic examination, photographs from the wreckage indicated that the material around the holes was deformed in a manner consistent with being punctured by high-energy objects. The characteristics of the material deformation around the puncture holes appear to indicate that the objects originated from outside the fuselage.

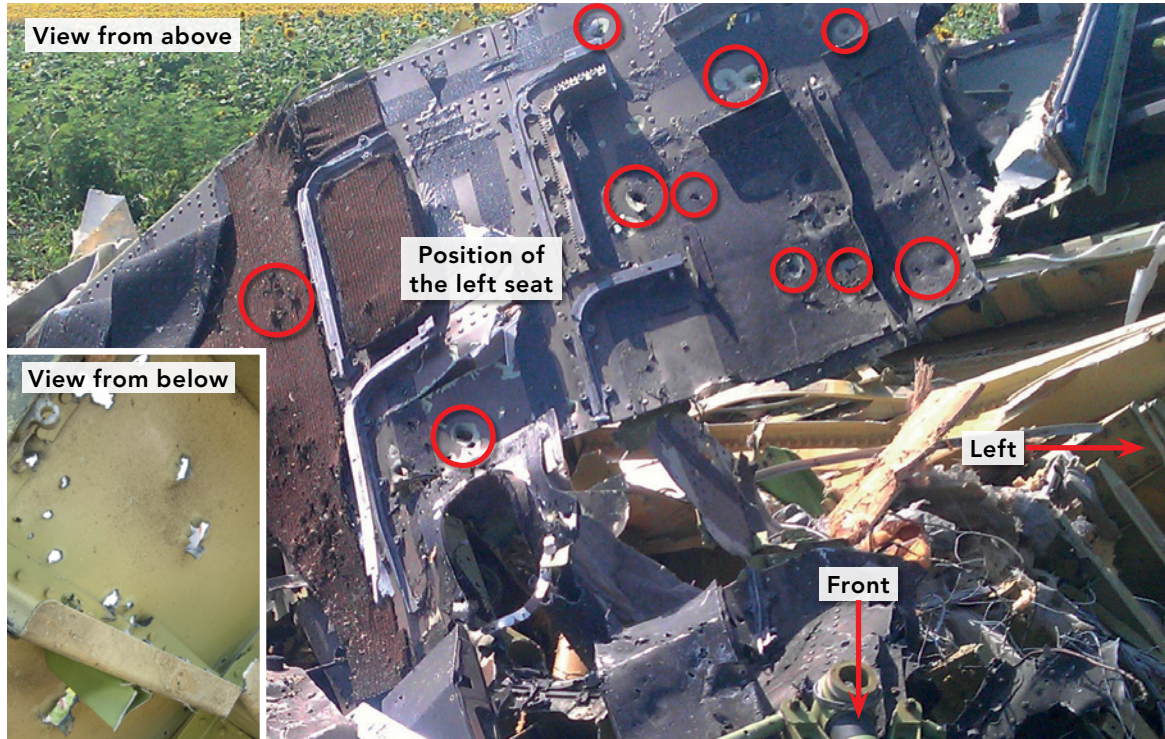
Puncture holes identified in images of the cockpit floor suggested that small objects entered from above the level of the cockpit floor (figure 10).

Figure 10: Cockpit floor with floor parts showing puncture holes (red circles) coming from above the floor.  
(Source: NBAAI)

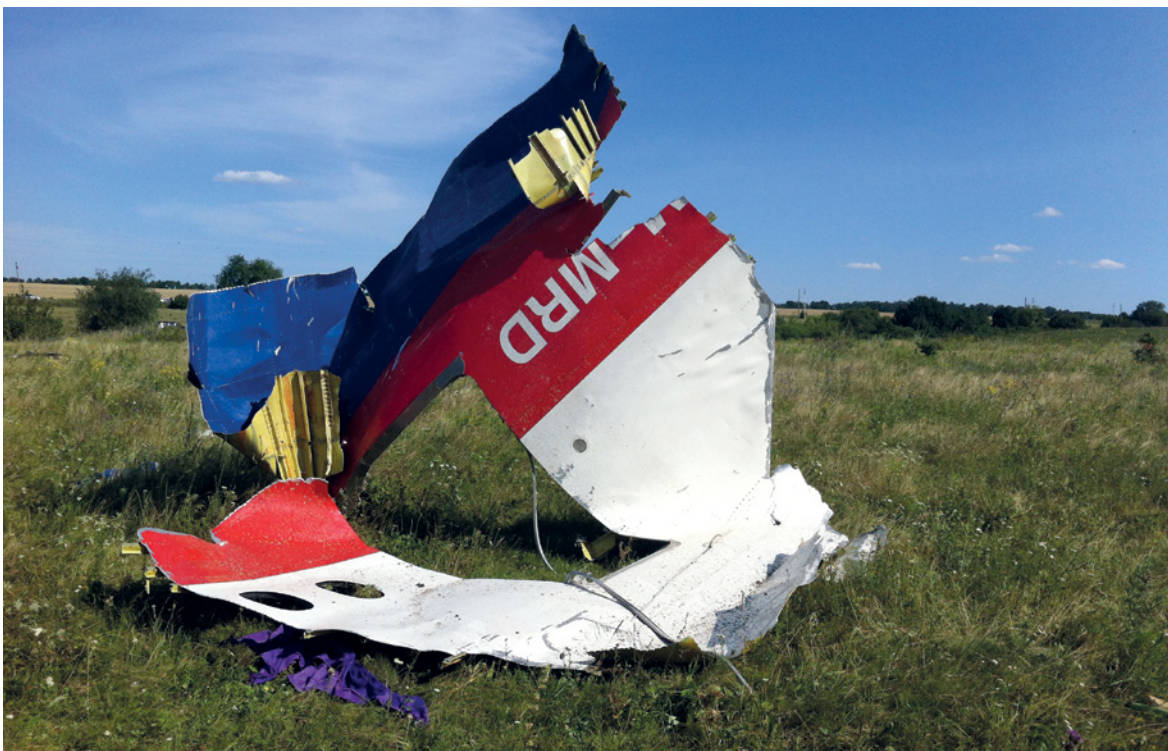
A section of aft fuselage skin from the right side (figure 13) was located 330 metres west of the vertical tail, and the left wing tip and right horizontal stabilizer were also in this location. The left horizontal stabilizer was found another 330 metres to the west.

Figure 13: Aft fuselage skin, right side, with partial registration of the aircraft. (Source: NBAAI)
