# **Preliminary report**

## Crash involving Malaysia Airlines Boeing 777-200 flight MH17

Hrabove, Ukraine - 17 July 2014

*The Hague, September 2014*

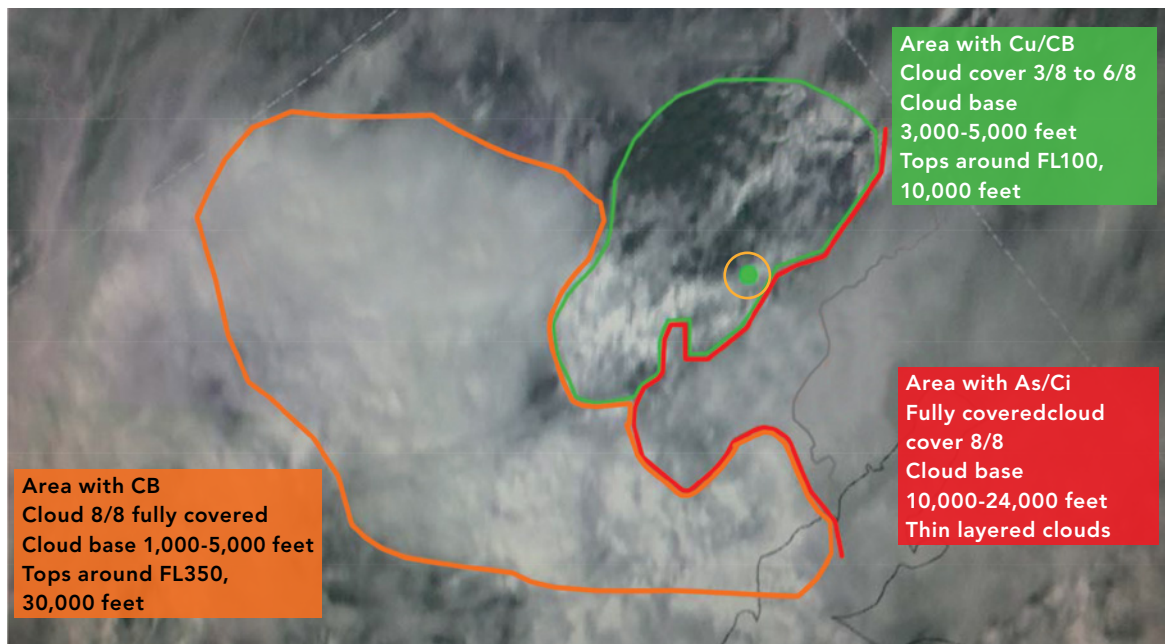
Figure 3: Cloud coverage for 17 July at 12.00 hrs.<sup>10</sup> The circled green dot indicates the last position of aircraft. The orange area south-west of the accident location contains mostly Cumulonimbus clouds with possible thundershowers. (Source: KNMI)

In the area three different types of weather could be distinguished, which is depicted in figure 3.

The orange area contains mainly Cumulonimbus clouds (rainclouds). The cloud coverage is mostly 8/8. The cloud base is around 3,000 to 5,000 feet, with the tops of the clouds reaching FL350 (35,000 feet).

The red area contains mainly Altostratus and Cirrus clouds, with cloud coverage being mostly 8/8, and the cloud base around 10,000 to 20,000 feet. The red area contains mostly thin layered clouds reaching 20,000 to 30,000 feet at places.

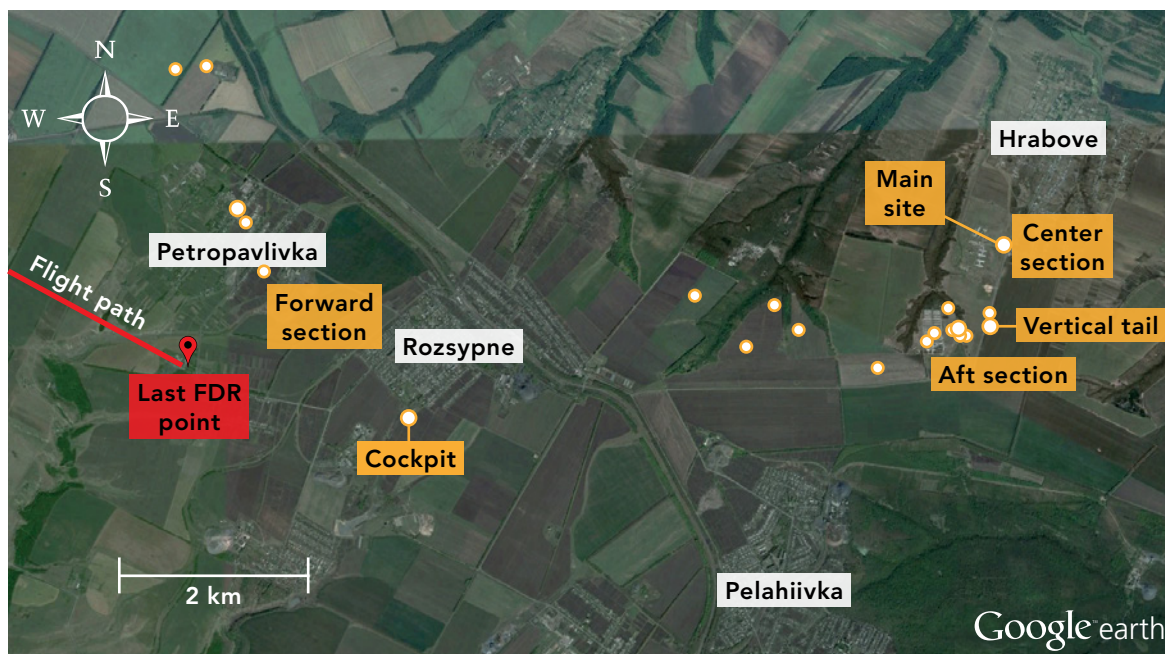
Figure 6: The last location of the aircraft in flight taken from the FDR. Wreckage distribution is grouped per section of the aircraft (Source: Google Earth, wreckage information Dutch Safety Board).

The aircraft wreckage, identified from the on-site photographs and satellite images, consisted of many large and small pieces distributed over an area of approximately 10 km by 5 km (figure 6). Fuselage pieces, cargo and baggage were scattered throughout the wreckage site. There were many additional unidentified pieces that are not shown in the figure. For easy reference the wreckage site has been divided into sections as shown in figure 6. These sections match with the aircraft sections shown in figure 7.

Large parts from around the cockpit and forward section were found in the area closest to the last recorded FDR position (figure 6). Among these parts were portions of the cockpit, the forward cargo bay floor and the cockpit side wall. The remains of the cockpit were located at the southern end of Rozsypne, 2.3 km east from the last recorded FDR position.
